# FLOOD MITIGATION & RESILIENCE REPORT

## Minisceongo Creek - SD112

New York State Department of Environmental Conservation,  
in cooperation with the New York State Office of General Services

September 2021

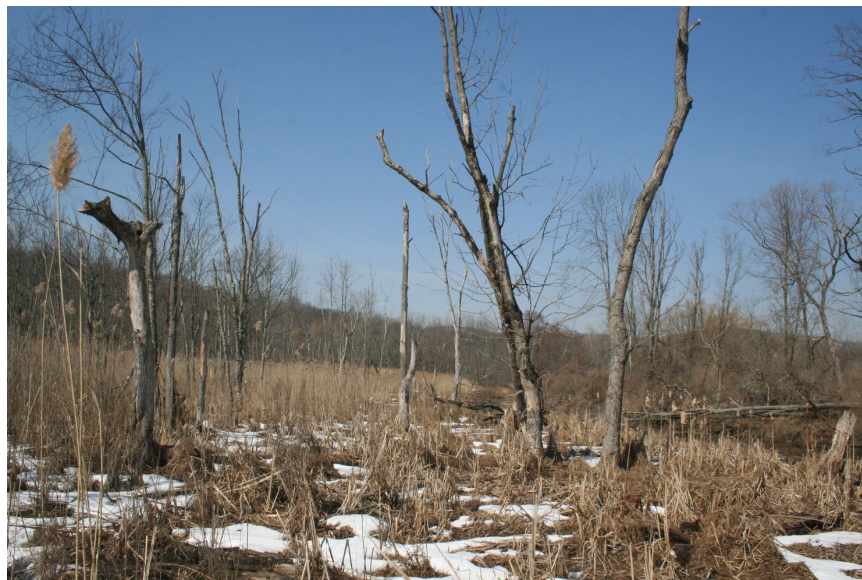
**Figure 2-6: Mount Ivy Swamp, a 410-acre NYSDEC-mapped wetland complex along South Branch Minisceongo Creek in the towns of Ramapo and Haverstraw**

Mount Ivy Swamp, a 410-acre NYSDEC-mapped wetland complex along South Branch Minisceongo Creek in the towns of Ramapo and Haverstraw, is pictured in Figure 2-6. Green Swamp, Grape Swamp, and other wetlands associated with Lake Welch are located near the headwaters of Minisceongo Creek.

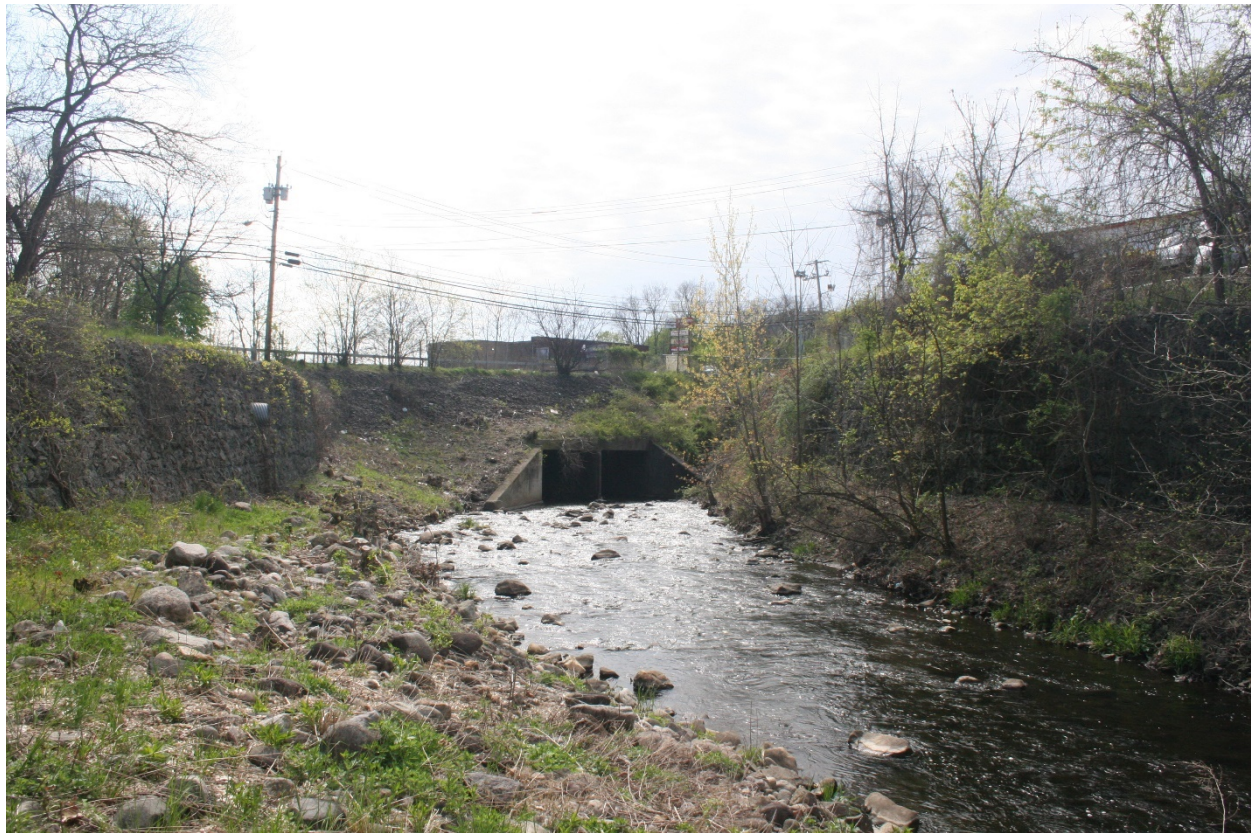
**Figure 4-2: View Looking Downstream at Route 9W Culvert Crossing of Minisceongo Creek**

The twin-barreled, four-sided box culvert that carries Route 9W across Minisceongo Creek at approximately STA 67+00 (National Bridge Inventory [NBI] Bridge Identification Number [BIN]: 1007130) was incorporated into the SMS/SRH-2D model developed for this study. The two approximately 10-foot by 10-foot culvert barrels were modeled as adjacent conduits with pressure boundary conditions. Normal two-dimensional open-channel flow is simulated through the culvert unless the upstream water surface exceeds the ceiling elevation, in which case pressurized flow is computed within the structures. This occurs in the modeled 500-year flood and predicted future 100-year flood scenarios.

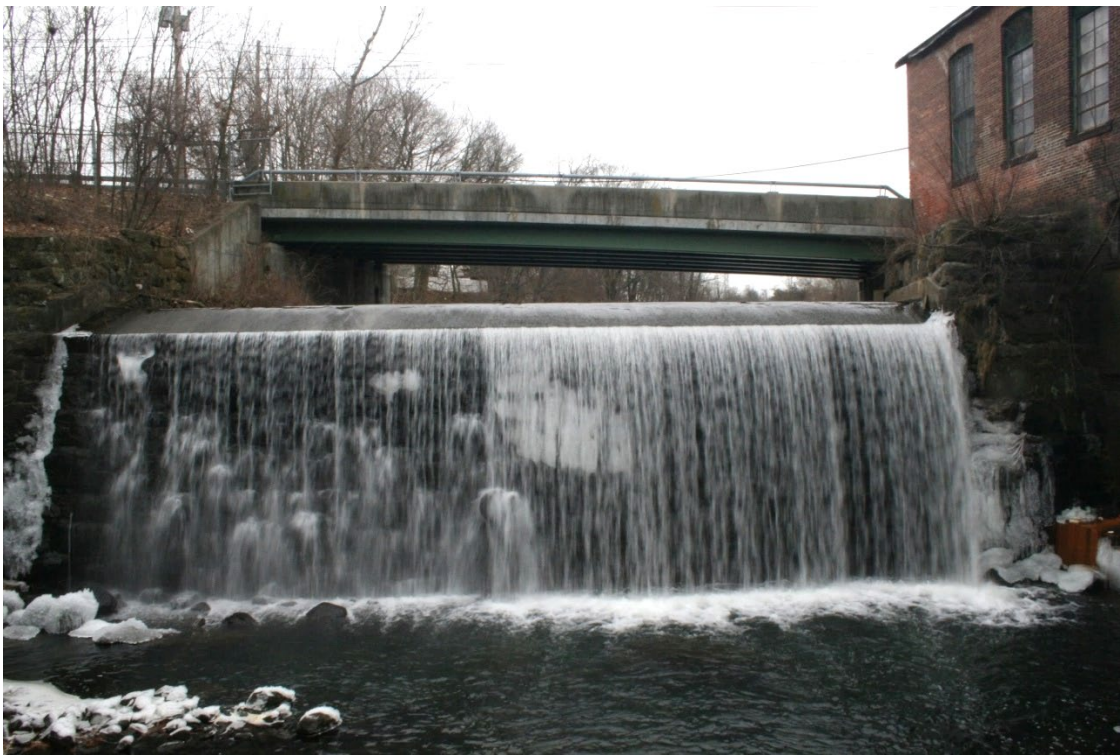
**Figure 4-6: View of the Bridge Street dam from downstream. The Bridge Street bridge is visible just upstream.**

The Bridge Street dam was reclassified as a Class A – Low Hazard dam in 2007. Removal or modification of this dam is unlikely as it contributes significantly to the character and aesthetic of the GAIC.

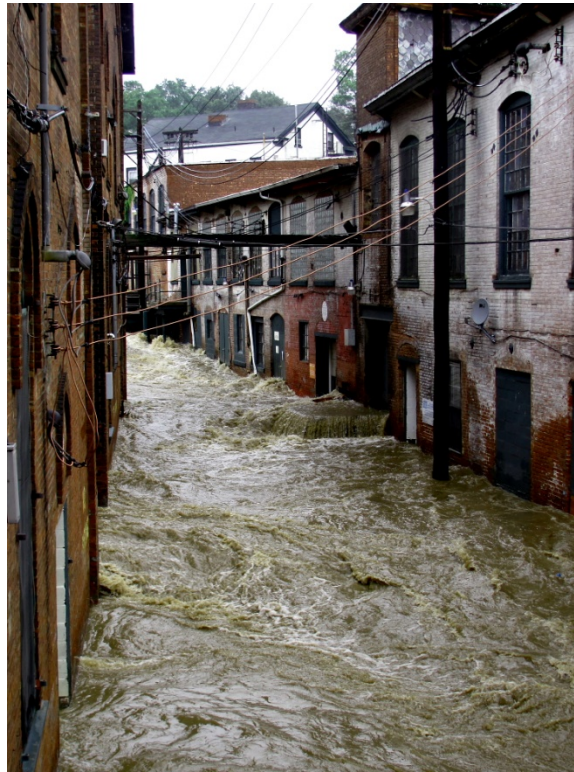
**Figure 4-9: Garnerville Arts & Industrial Center during Tropical Storm Irene in 2011. View looking upstream from Building #5. Photo courtesy of Garnerville Arts & Industrial Center.**

At the GAIC, two buildings span the creek as it flows between the historical mill buildings that compose both banks from STA 93+60 to STA 100+50 (Figure 4-8). Extensive flooding and debris jamming during Tropical Storm Irene in 2011 (Figure 4-9) resulted in partial collapse of one of the walls that define the stream banks.

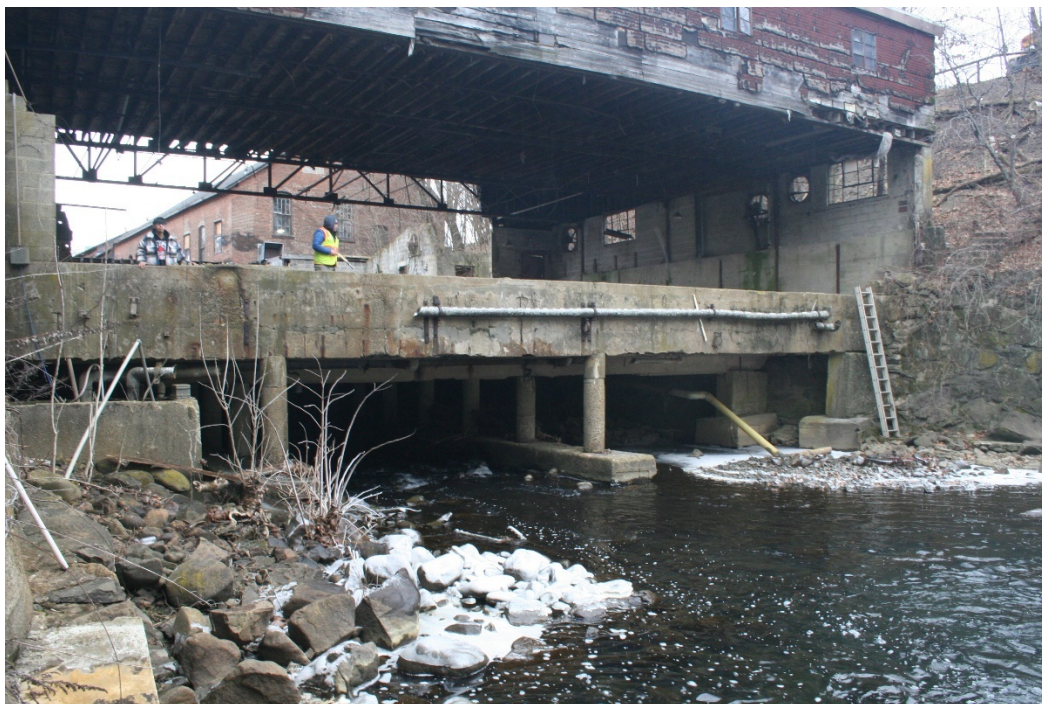
**Figure 4-10: View looking downstream at Building 26A at the GAIC just downstream of the Bridge Street dam. Piers and other obstructions restrict flow and are prone to debris jamming.**

Modeling demonstrates that in the vicinity of the GAIC there is complex hydraulic interdependence between the bridge, the dam, and the two building crossings in the context of a laterally confined, vertically walled channel. The upstream structure spanning the creek, Building 26A, shown in Figure 4-10, is undersized for flood flows, and the building's piers exacerbate flooding by obstructing flow in clear water flood conditions. These piers are also prone to snagging debris, which may increase upstream flood inundation extents as well as the proportion of flows that flank the GAIC to the north. The floor of Building 26A is modeled as overtopping by as much as 9 feet in the 100-year flood. This reportedly occurred in Tropical Storm Irene, during which extensive debris jams developed against the piers beneath the structure as well.

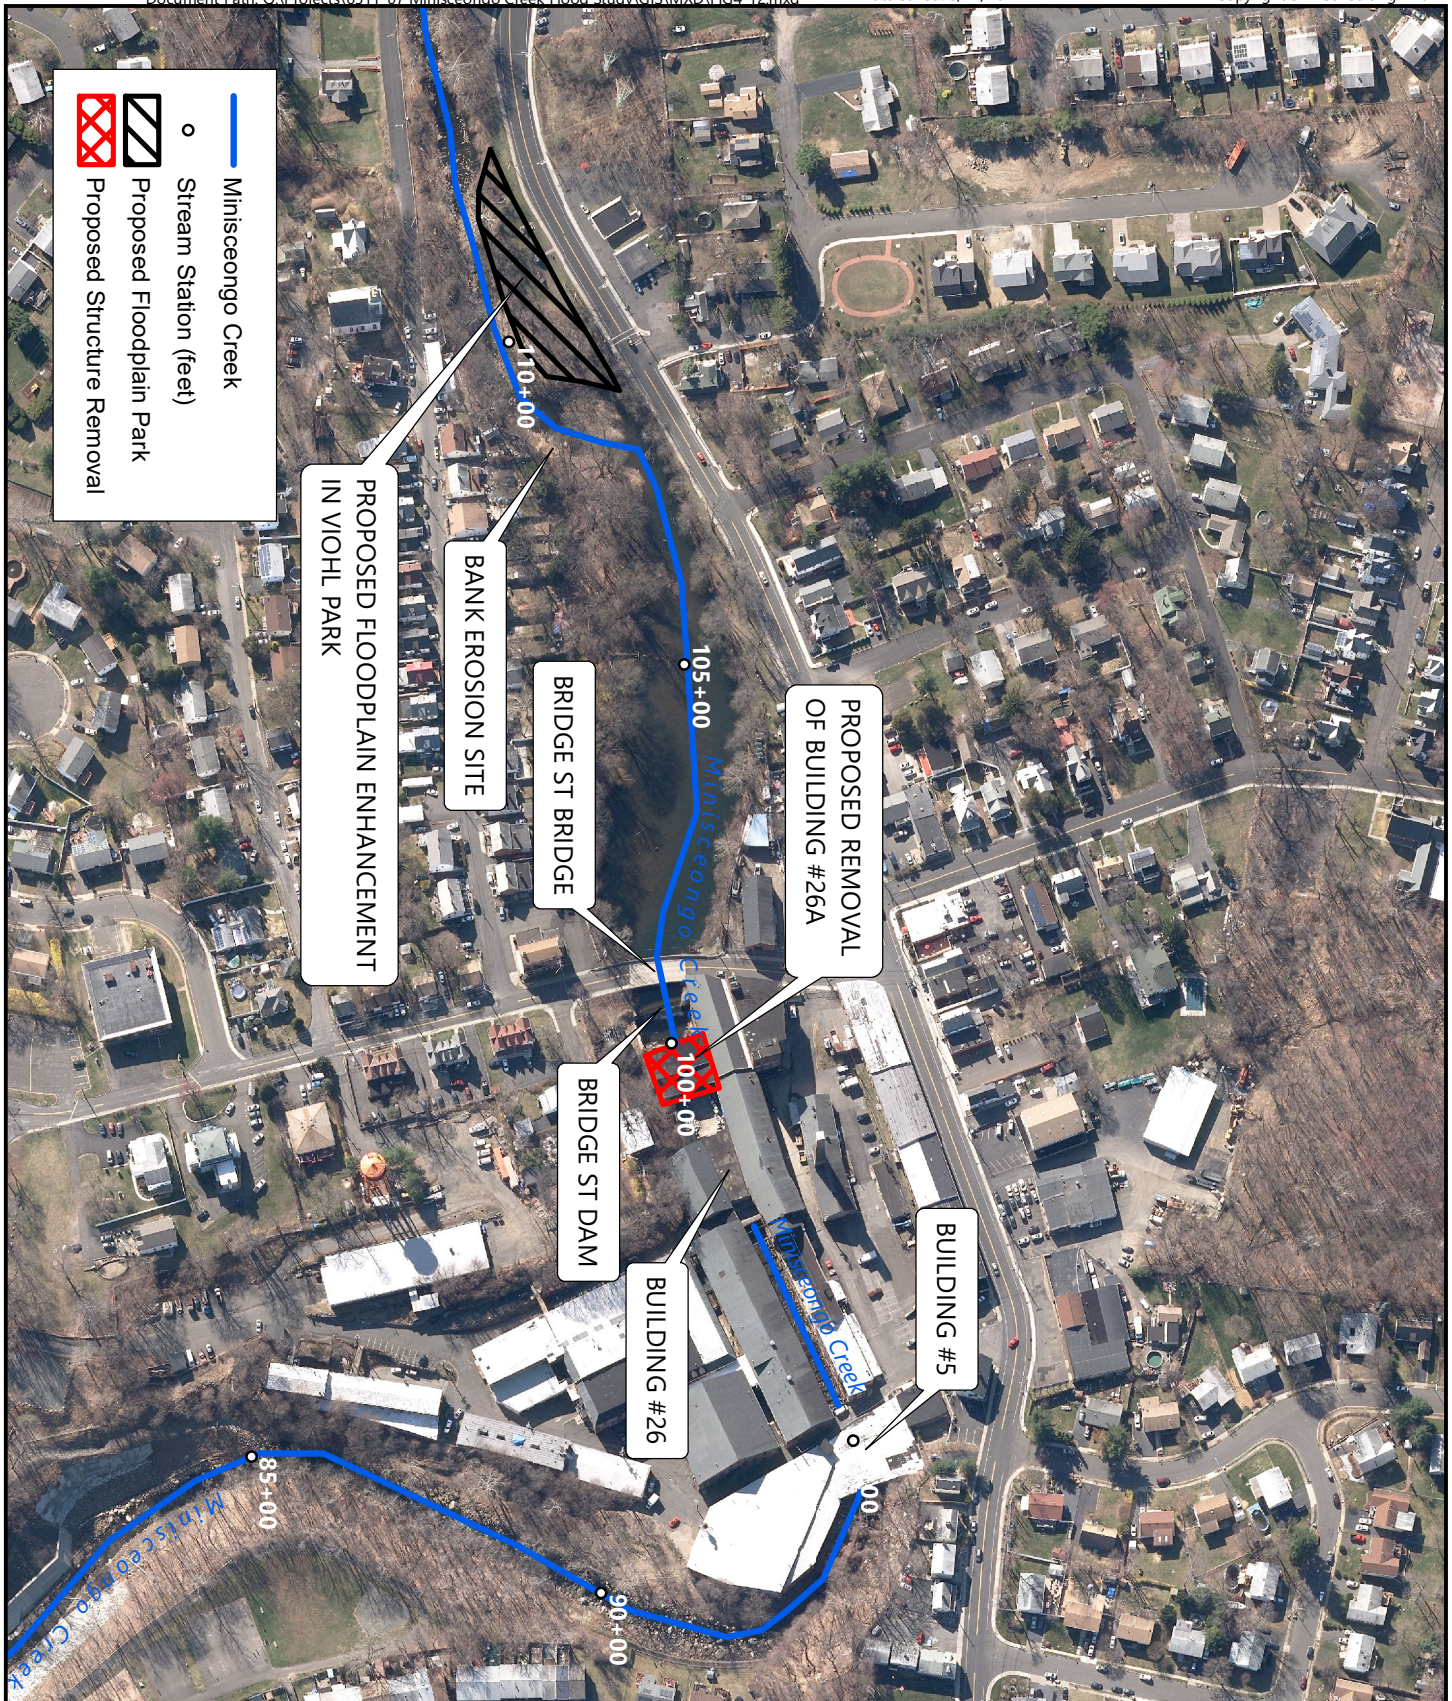
| <b>FIG. 4-12</b> | PROJ. NO. | 16511.00007 | <b>MINISCEONGO CREEK HIGH RISK AREA #2 CONCEPT MAP</b><br>MINISCEONGO CREEK FLOOD & RESILIENCY STUDY<br>SD112<br>ROCKLAND COUNTY<br>NEW YORK | 231 MAIN STREET<br>SUITE 102<br>NEW PALTZ, NY 12561<br>845.633.8153 | <br>0 140 Feet |

Floodplain benching along 250 feet of the left bank upstream of the right bank erosion site was modeled to assess whether the creek's energy may be diffused before encountering this bank and whether this may have significant flood hazard mitigation benefits. The affected area contains Viohl Park, which would be proposed to be relocated to this new floodplain, between 4 feet and 6 feet lower in elevation but otherwise essentially unchanged and with only a nominal loss of area. This floodplain enhancement was modeled alone and in combination with removal of Building 26A at the GAIC and is depicted as a conceptual layout in Figure 4-12. Results indicate that the floodplain bench would be effective at reducing 100-year flood velocities along the actively eroding bank by 25 percent and shear stresses by 28 percent. This does not address the backwater deposition issue but would reduce hydraulic erosion along the toe of the bank under clear water conditions due to the substantial decrease in erosive energy. However, when this floodplain is modeled in combination with removal of Building 26A and its piers, not only are

would require between 4 feet and 6 feet of excavation along 250 linear feet of Minisceongo Creek, is depicted as a conceptual layout in Section 4.2, Figure 4-12 of this report.

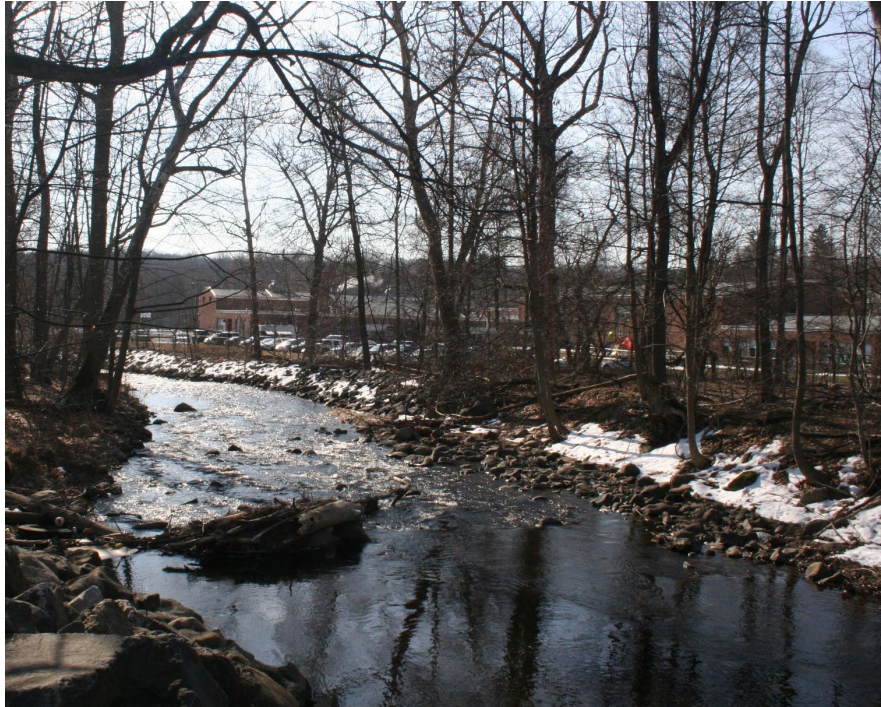
**Figure 4-13: Thiells Elementary School Viewed from Suffern Lane**

HRA 3 is located in Thiells, a hamlet in the town of Haverstraw (Figure 4-14). Thiells Elementary School is situated along Minisceongo Creek (pictured in Figure 4-13) at STA 180+00 and is mapped as being partially within the SFHA delineated by FEMA. The Director of Facilities for the North Rockland School District has reported that the school building experienced severe flood damage during Tropical Storm Irene in August 2011, with flooding along the north side of the school building, which is closest to the creek. Water entered the building through the HVAC system and flooded approximately two-thirds of the first floor. Extensive repairs were required, including replacement of sheetrock and renovation of the library. During Superstorm Sandy in 2012, water flooded the school parking lot but did not damage the building.

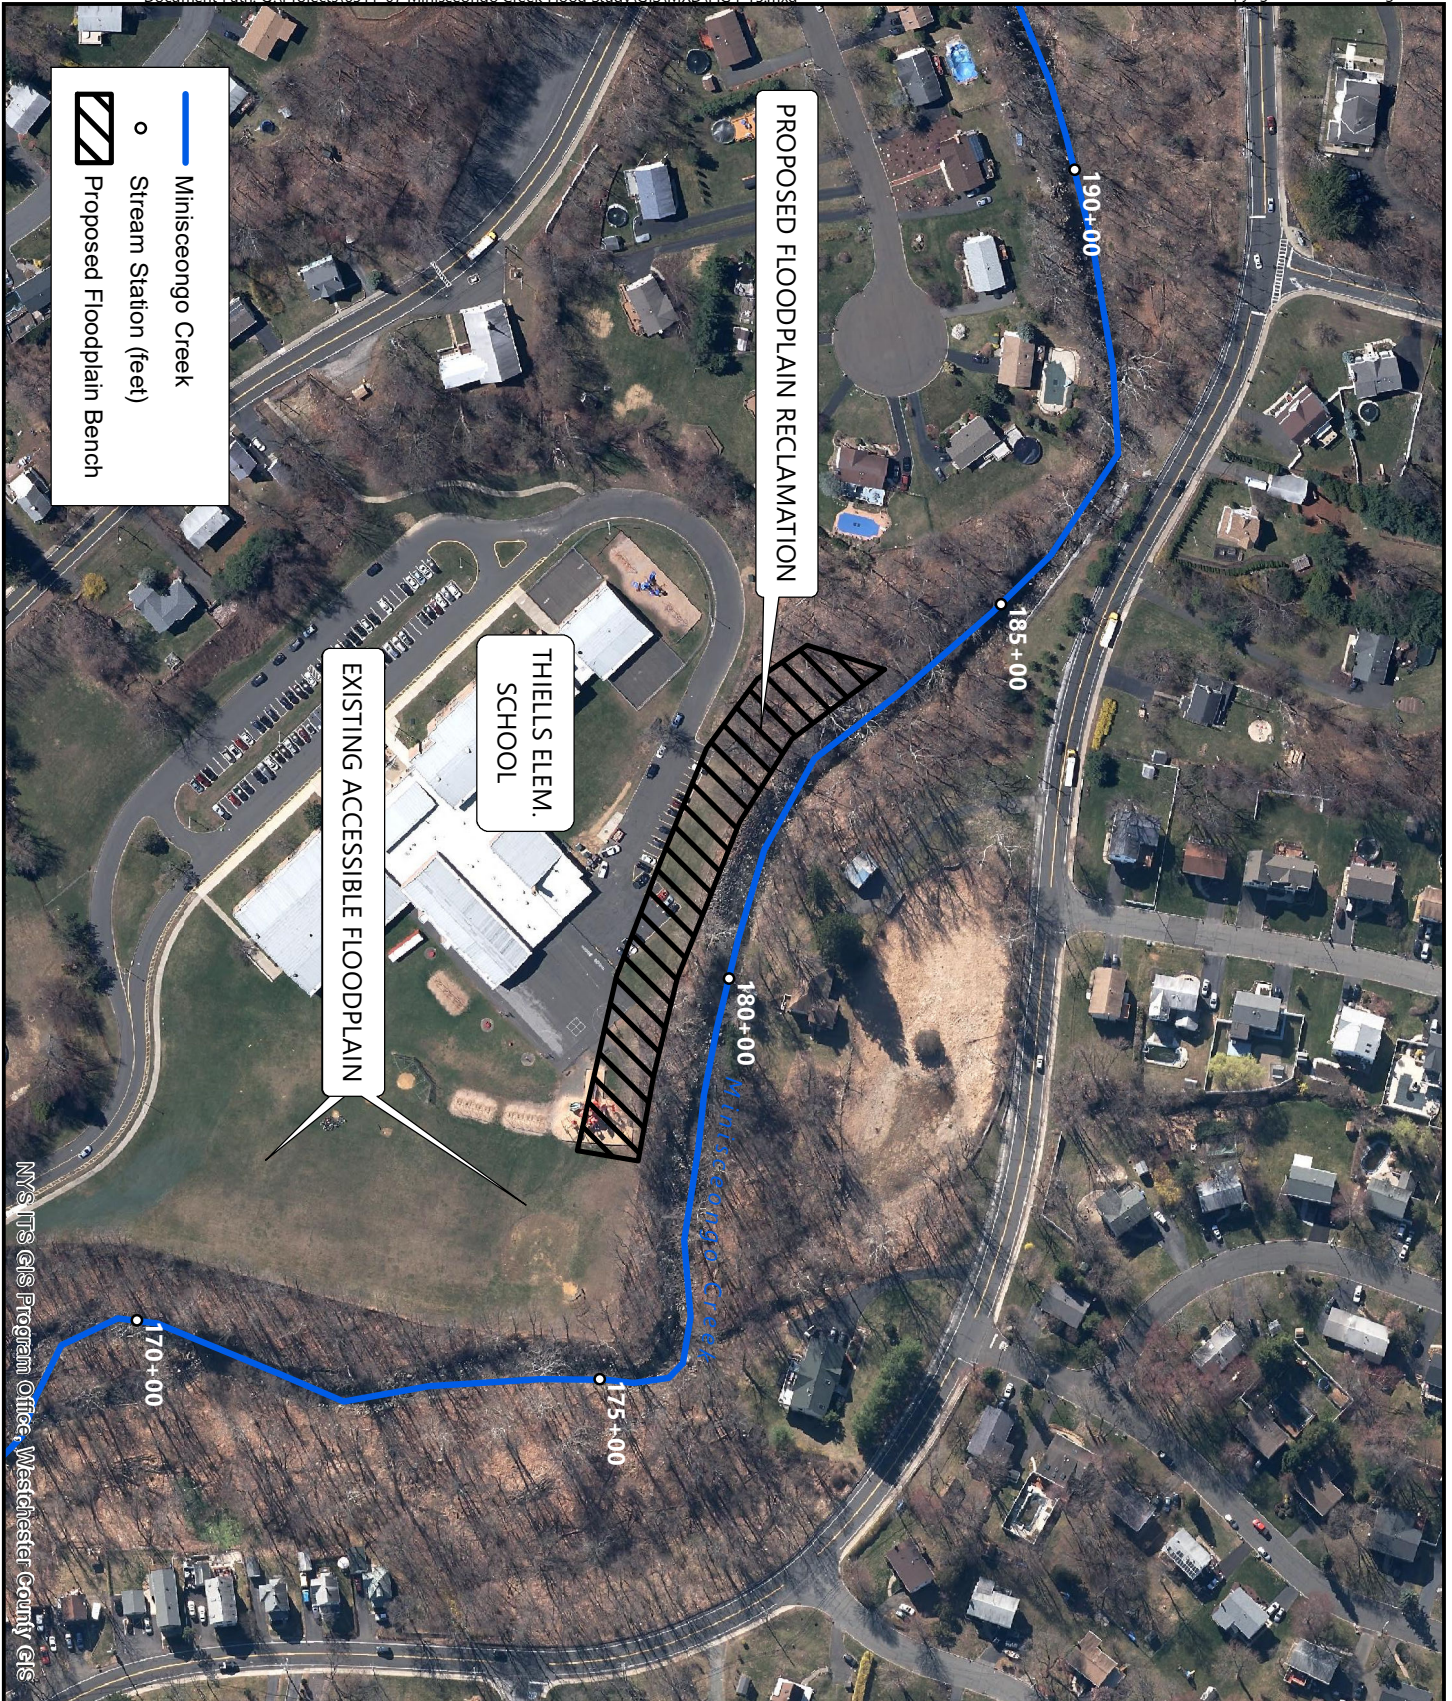
**FIG. 4-15**

To assess whether flooding of the Thiells School can be alleviated by containing floodwaters within a narrower but more accessible floodplain, a 60-foot-wide bench along approximately 550 linear feet of Minisceongo Creek's right (south) bank was modeled where the creek flows along the north side of the school. This alternative requires reclamation of several parking spaces and relocation or reconfiguration of a playground structure. This provides supplemental flood flow conveyance at a lower elevation than the school buildings at the critical location where water leaves the primary channel. A conceptual layout of the floodplain bench is depicted on Figure 4-15.

The terrain surface elevation within this simulated floodplain was reduced by between about 1 foot to about 6 feet within this roughly 1-acre area, representing about 5,500 cubic yards of material. The shallowest cutting is at the floodplain's upstream extent, and the depth grows downstream as the bench follows the river's slope, ultimately tying in to the elevation of the sports fields just east of the school. This results in up to a 1.1-foot decrease in flood water surface elevations in the modeled 100-year event and a 1.6-foot reduction in the 500-year flood. In the modeled future 100-year flood scenario, water surface elevation (WSEL) was reduced by 1.4 feet. With these reductions, the building is not expected to experience flooding in either the current or projected future 100-year flows, and flood depths would be limited to less than 0.2 feet along the northern side of the school building during the 500-year discharge. A drop in in-channel velocity of 2 to 3 fps is also observed where this floodplain bench was simulated.

Following further, detailed hydrologic and hydraulic analyses, design and construction of the proposed 550-foot-long, 60-foot-wide floodplain bench along Minisceongo's right (south) bank where it flows along the north side of the Thiells School are recommended. Required excavation begins at about 1 foot at the upstream end and increases downstream as it matches the natural channel slope, up to about 6 feet at the downstream end of the proposed floodplain, for a total of roughly 5,500 CY of export. Under this scenario, flooding of the elementary school would no longer be expected in the current or projected future 100-year floods; depending on the location, orientation, and elevation of doors, windows, and ventilation intakes, very minor floodproofing measures can further alleviate flooding of the school in the 500-year event. A conceptual layout of the floodplain bench along Minisceongo Creek is depicted in Section 4.3, Figure 4-15 of this report.

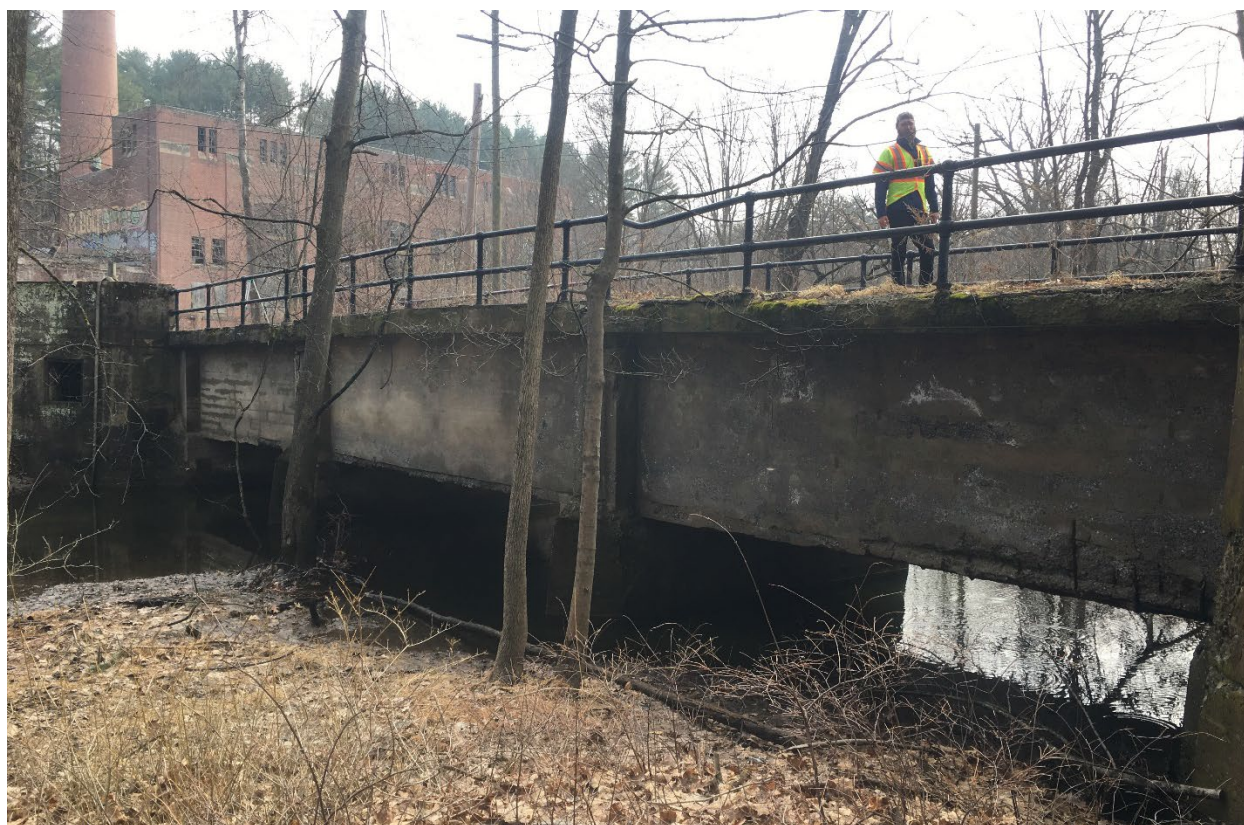
Figure 4-23: Rockland Print Company Power Plant Bridge

About 1,300 feet downstream of the Storrs Road bridge, a derelict three-span, single-lane bridge crosses Minisceongo Creek, pictured in Figure 4-23. This structure once provided access to the power generation building complex for the Rockland Print Company, which itself has been abandoned and is in a state of disrepair. The bridge has an unusually thick superstructure and deck, which combine to be roughly 8 feet in height. The structure's NAACC crossing code is xy4121177674026762, and it was evaluated as being an *insignificant barrier* to fish passage with a NAACC aquatic passability score of 0.94 out of 1.0. Deep scour was observed in the channel bed underneath the span, which is modeled as pressurizing in the 50-year flood and greater. Because this structure is no longer necessary and is a safety hazard in its deteriorated condition, removal of the crossing was simulated to assess whether eliminating the hydraulic constriction would have any flood mitigation benefits upstream or in the adjacent areas. Minor reductions in upstream flood water surface elevations were observed, but simulated bridge removal did not significantly improve conditions at nearby infrastructure or buildings under clear water flood conditions. Nevertheless, the bridge is susceptible to debris jamming, and the structure itself would create a significant obstruction to flow in the event of failure.

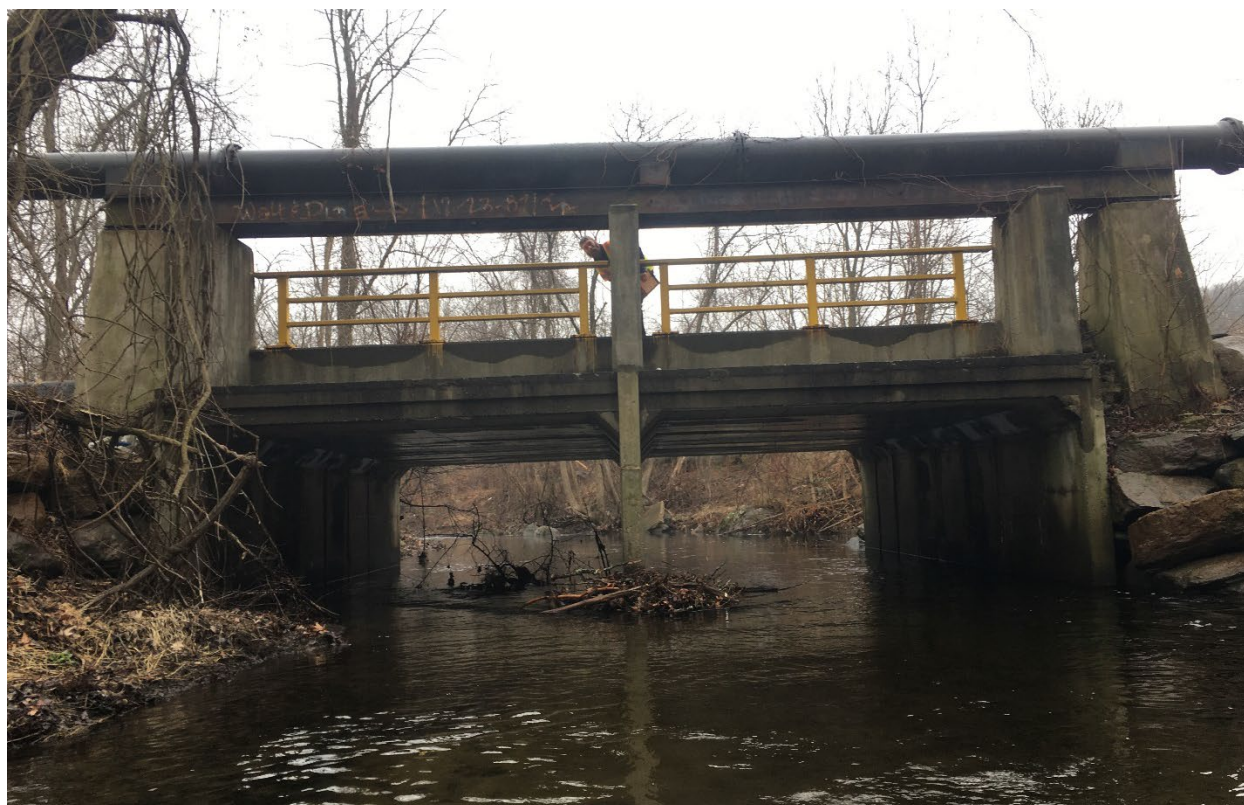
Figure 4-24: West Haverstraw DPW Facility Bridge

Approximately one mile downstream of the old power plant, after flowing through a golf course, confluencing with its South Branch, and passing under Thiells Mount Ivy Road/CR-47, Minisceongo Creek meets an unnamed tributary coming in from the south just before beginning what amounts to a nearly 180-degree bend. Here, the West Haverstraw DPW facility is accessed via a twin-barreled, four-sided box culvert, pictured in Figure 4-24. The structure's NAACC crossing code is xy4119982174027117, and it was evaluated as being an *insignificant barrier* to fish passage with a NAACC aquatic passability score of 0.90 out of 1.0. Each opening measures 8± feet high by 14± feet wide. What appears to be a sanitary utility line crosses the creek immediately upstream of the culverts but is elevated above the modeled 500-year clear water flood water surface. Modeling indicates that the culverts can pass up to the 50-year flood under open-channel flow conditions. The culvert can pass the 100-year flood with about 1 foot of pressure head at the inlet and the future 100-year flood scenario with just over 2 feet of pressure head. The modeled 500-year flood overwhelms the structure and overtops the road. Flooding may be more severe in the event of wood or debris jamming at the culvert barrels. Replacement of these culverts with an adequately sized bridge span may help preserve access to this critical facility during flood events and in their aftermath. Based on this analysis, a minimum span length of 80 feet is recommended, which meets NYSDEC stream crossing guidance of 1.25 times the river's bankfull width; detailed updated hydrologic and hydraulic analyses are recommended prior to replacement of or significant upgrades to this structure.

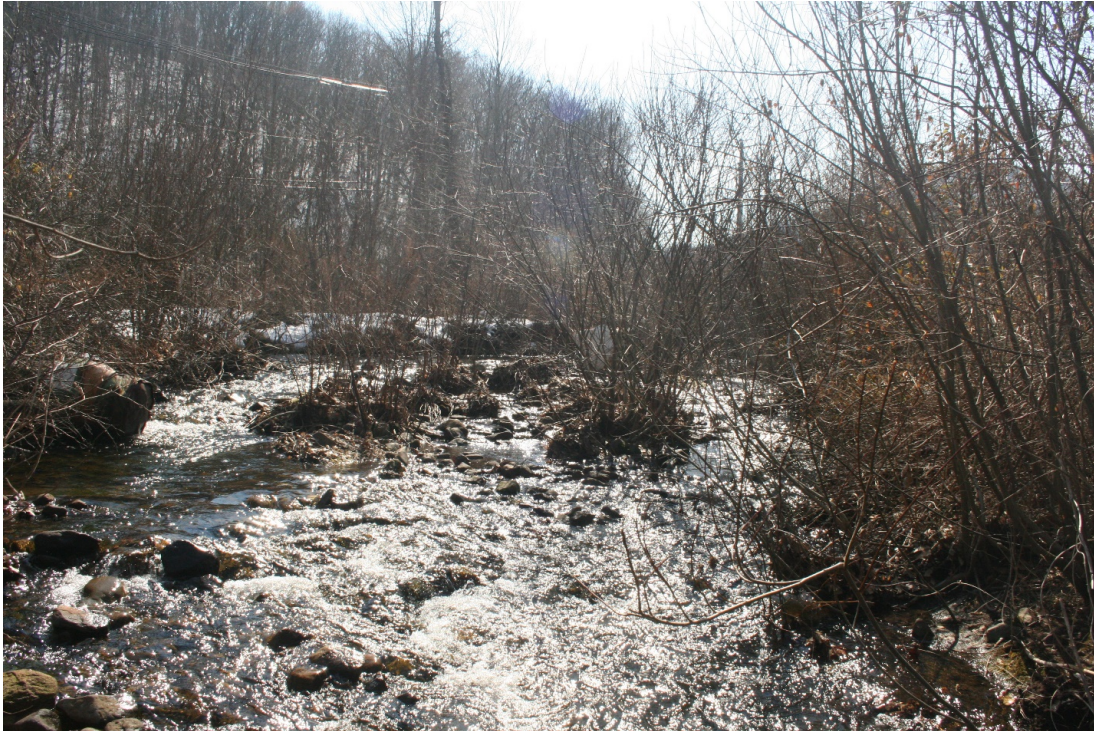
**Figure 4-27: Dynamic Channel Upstream of Willow Grove Mobile Home Park**

Minisceongo Creek flows out of Lake Welch and through a steep, confined gorge before entering HRA 5. As Minisceongo Creek approaches Action Metal Company and Willow Grove Mobile Home Park, the channel exhibits a sharp decrease in slope (from approximately 11.9 percent to 1.7 percent, see Figure 4-26) and a widening river valley. These stream characteristics create a very dynamic environment (see Figure 4-27) due to the large volume of sediment and debris that tends to deposit in these settings during large floods. Minisceongo Creek transitions from a steep, high energy, confined stream as it flows through the gorge, to an unconfined, dynamic setting as the channel abruptly flattens upstream of Willow Grove Mobile Home Park, to a highly channelized and confined setting as it passes alongside Willow Grove Mobile Home Park and flows alongside and under Call Hollow Road.

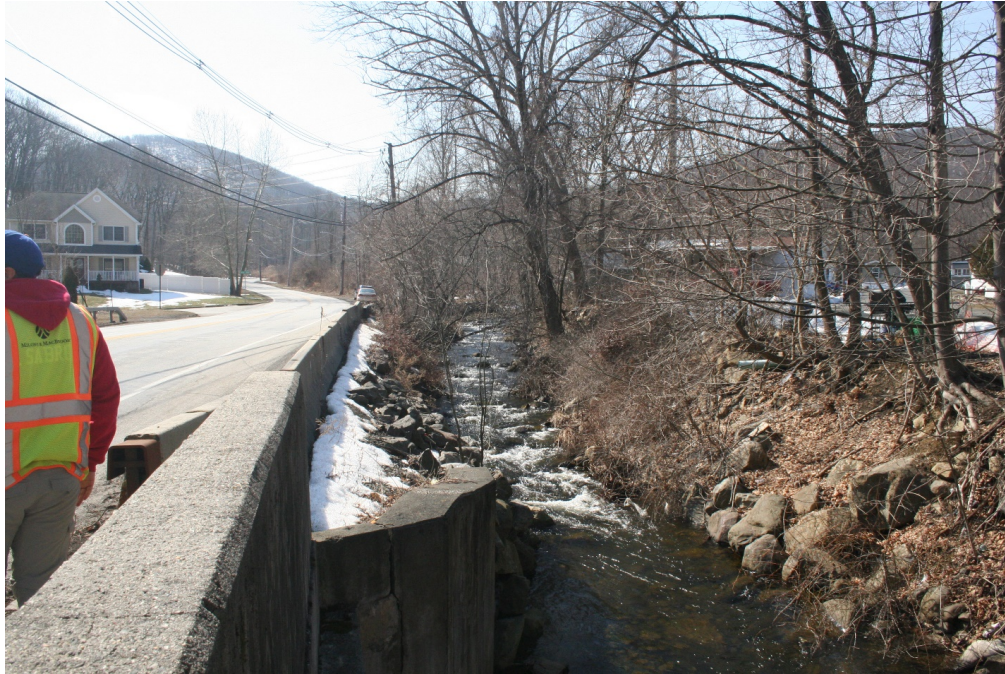
**Figure 4-29: Confined Channel between Call Hollow Road and Willow Grove Mobile Home Park**

As the creek passes alongside Willow Grove Mobile Home Park, gabion block walls that line the banks have been undermined and have toppled into the creek (Figure 4-28). Regional regression equations indicate that the bankfull geometry of Minisceongo Creek in this area should have a width of approximately 60 feet while the measured channel width as the creek passes between Willow Grove Mobile Home Park and Call Hollow Road is a mere 30 feet (Figure 4-29) and lacks a floodplain. The stream crossing at Call Hollow Road is also inadequately sized and is positioned at a poor angle relative to the creek.

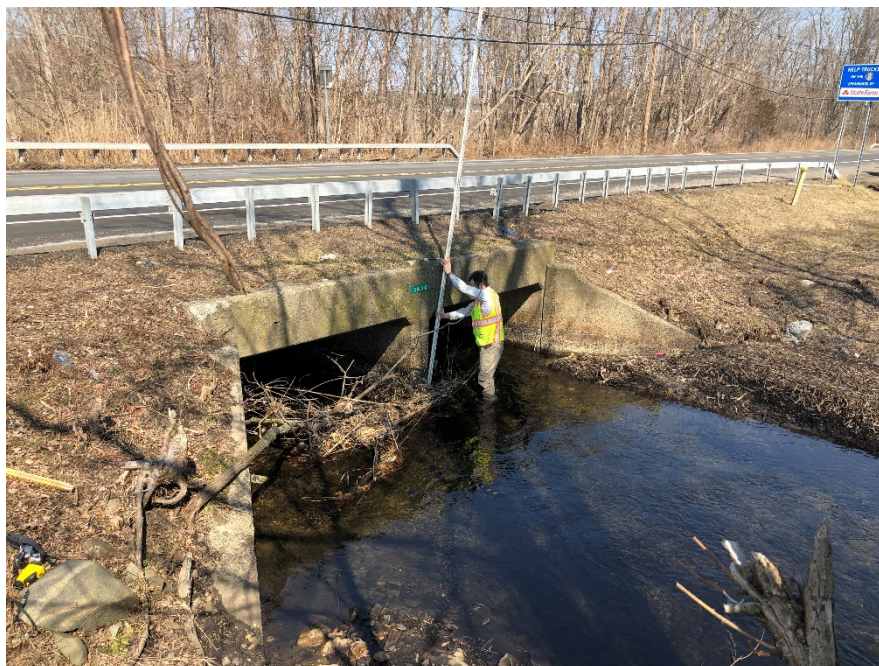
**Figure 4-31: Inlet of Stream Crossing Structure under US Route 202**

The hydraulic modeling analysis indicates that the combined capacity of these culverts is 597 cubic feet per second (cfs), which is above the existing and future 100-year peak discharges of 515 cfs and 572 cfs, respectively. This finding indicates that the culverts are not a severe hydraulic constriction and do not contribute to flooding of the road. In addition, a debris jam sensitivity analysis was conducted to understand the impact of debris accumulation at the culvert inlet as observed in the field. Modeling this scenario showed that if either box opening was blocked by 50 percent the total capacity would be reduced to 352 cfs, or 60 percent lower than the unobstructed condition. Roadway overtopping would begin at the 25-year storm, with a likelihood that upstream businesses would be flooded. The peak flow values used in this assessment are summarized in Table 4-3.

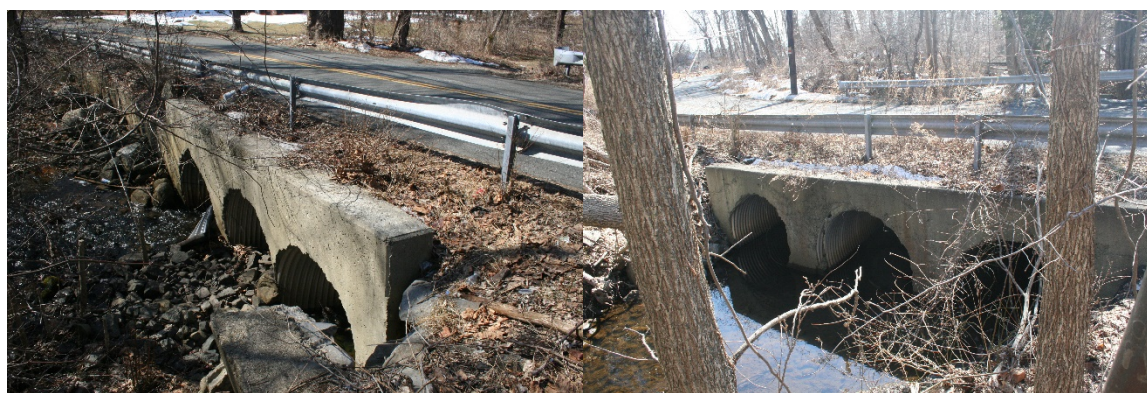
**Figure 4-33: Inlet of Upstream Culverts (Left) and Outlet of Downstream Culverts (Right) on South Camphill Road**

HRA 7 is located in the town of Ramapo (Figure 4-34). South Camp Hill Road crosses over South Branch of Minisceongo Creek two times just north of Pomona Road. The upstreammost structure is located near STA 190+00, its NAACC crossing code is *xy4116843174049633*, and it was evaluated as being a *minor barrier* to fish passage with a NAACC aquatic passability score of 0.80 out of 1.0. The downstreammost structure is approximately 650 feet downstream near STA 183+50, its NAACC crossing code is *xy4116998574050192*, and it was evaluated as being a *minor barrier* to fish passage with a NAACC aquatic passability score of 0.78 out of 1.0. The hydraulic performance of each stream crossing was investigated using the FHWA's *HY-8 Culvert Hydraulic Analysis* program. The existing structures under South Camphill Road consist of three, 5-foot-diameter, circular corrugated metal culverts with a concrete headwall (Figure 4-33).
